BID/ RFP ADDENDUM 01

3600 M Street, Merced, California 95348-2898 BID/ RFP TITLE: CAREER CENTER INTERIORS UPGRADES

Re: Asbestos Bulk samples
Merced College Student Union – Rms 137, 138, 138
3600 M Street
Merced, CA
Job No. B67-24

Job B67-24 / Sample Location Diagram Merced College – Student Union / 3600 M Street, Merced, CA Marcus Metcalf / Merced Community College District Drawing not to Scale

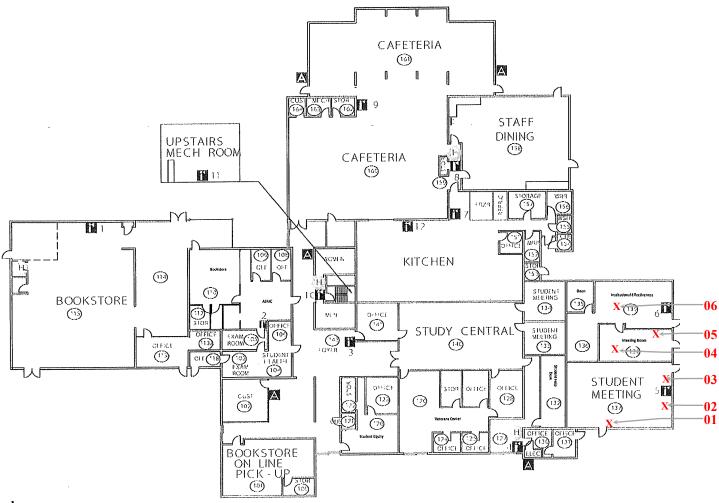
- Campico ita	guille for Assestes		
Sample	Location	Material	% Of ACM	Friable
01	Room 137 Floor	Carpet Glue	ND	
02	Room 137 Floor	Carpet Glue	ND	
03	Room 137 Wall	Basecove Mastic	ND	
04	Room 138 Floor	Carpet Glue	ND	
05	Room 138 Wall	Basecove Mastic	ND	
06	Room 139 Floor	Carpet Glue	ND

All samples of suspect materials from the selected areas of this site were negative for asbestos.
